**PHASE I - INSPECTION REPORT  
NATIONAL DAM SAFETY PROGRAM**

**COLSTRIP EVAPORATION POND DAM  
ROSEBUD COUNTY, MONTANA  
MT - 3211**

**JUNE 1981**

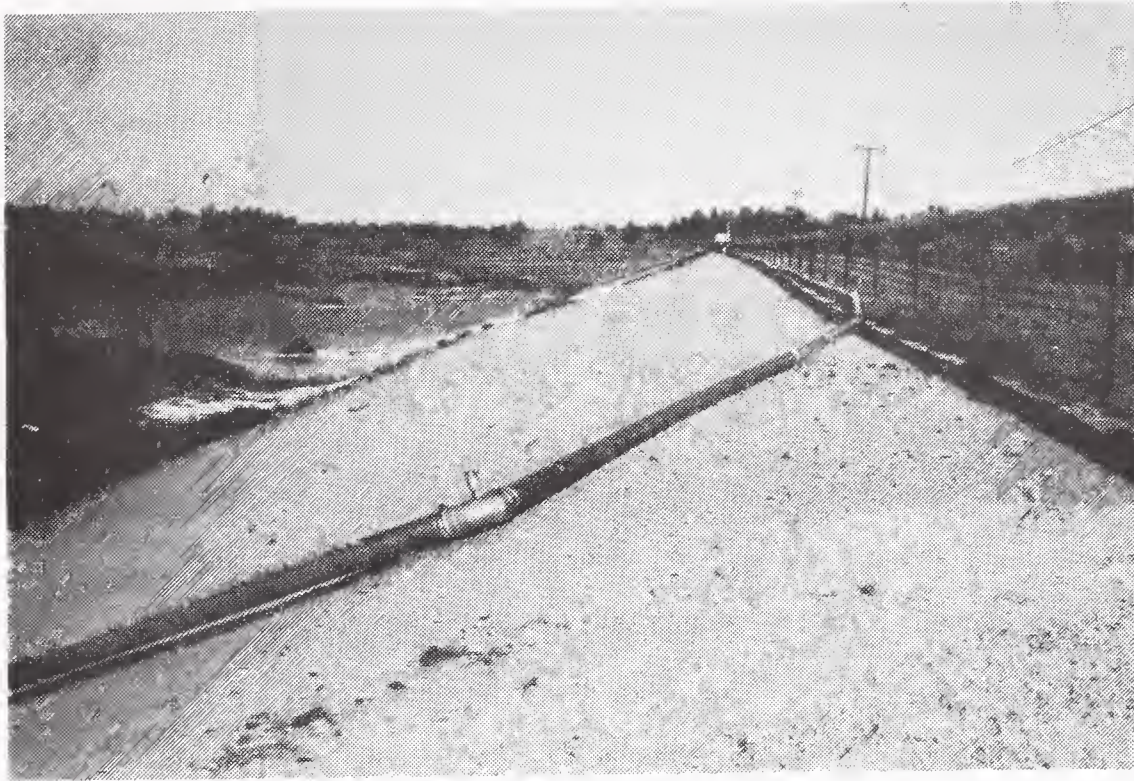
The inspection found no evidence of settlement, cracking, or misalignment along the dam crest (Photo 1). No traffic damage was observed on the crest service road. (See owner comment G in Appendix)

No cracking, differential movements, or misalignments were observed along the dam crest, slopes, or abutment contacts. (Photo 1) Only minor surficial sloughing was seen at isolated locations on the downstream slope. (Plate 5) No seepage was encountered. However, reservoir levels attained to date are well below design levels.

PHOTO 1  
Upstream Slope  
Note: Slurry Pump Barge in Pond

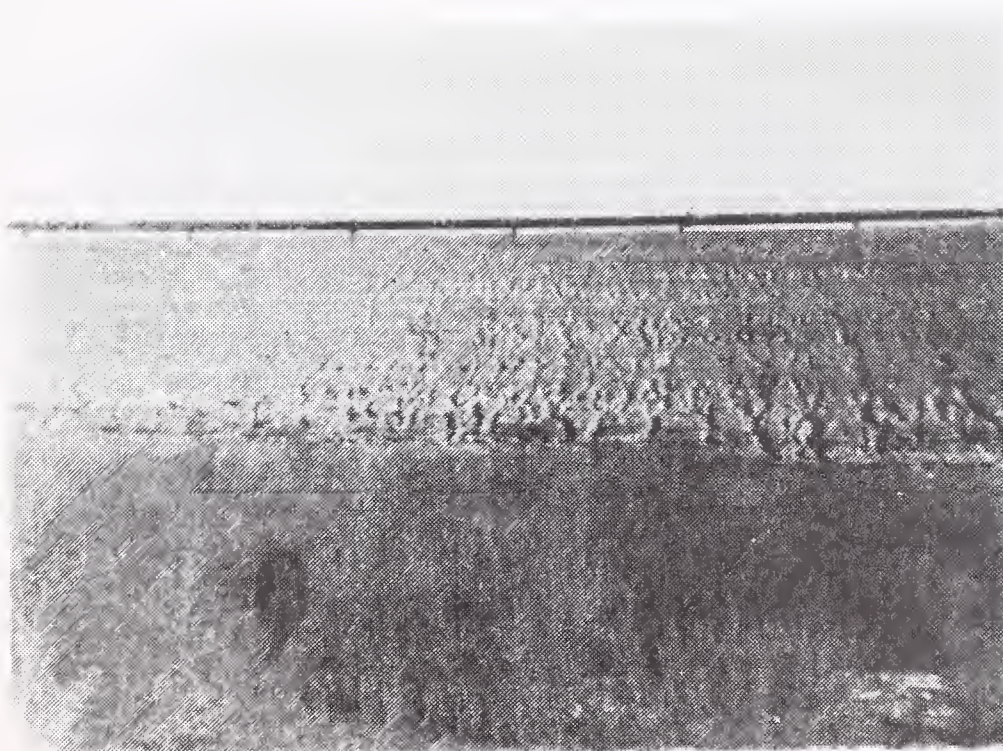
The soil-cement protection of the upstream slope has undergone minor runoff and wave erosion damage. (Photos 2 and 3) A localized area of substantial erosion has occurred near pond level on the upstream slope due to pump discharge. (Photo 4)

PHOTO 2  
Runoff Erosion on Upstream Slope

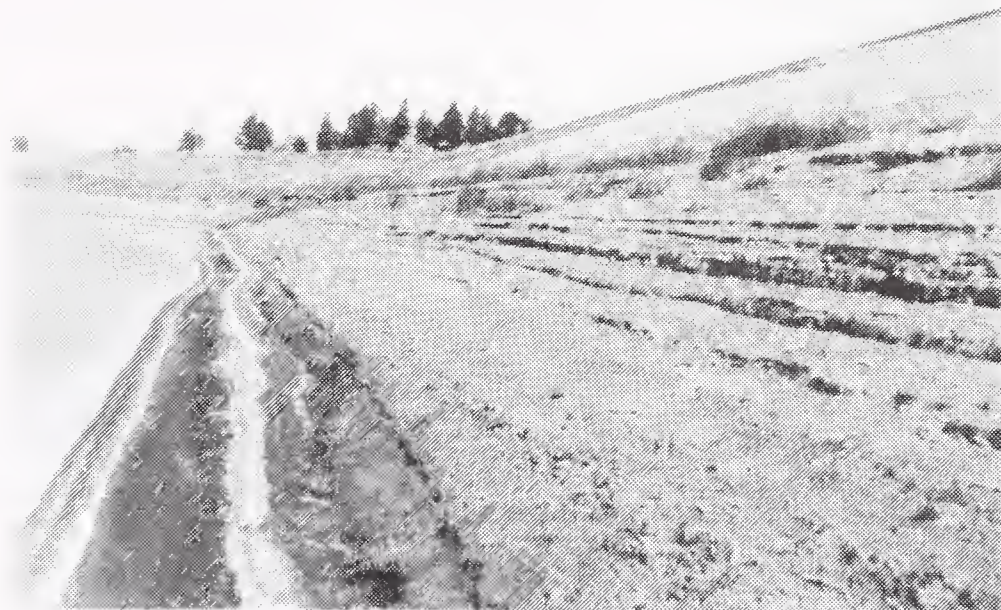
PHOTO 3  
Wave Erosion

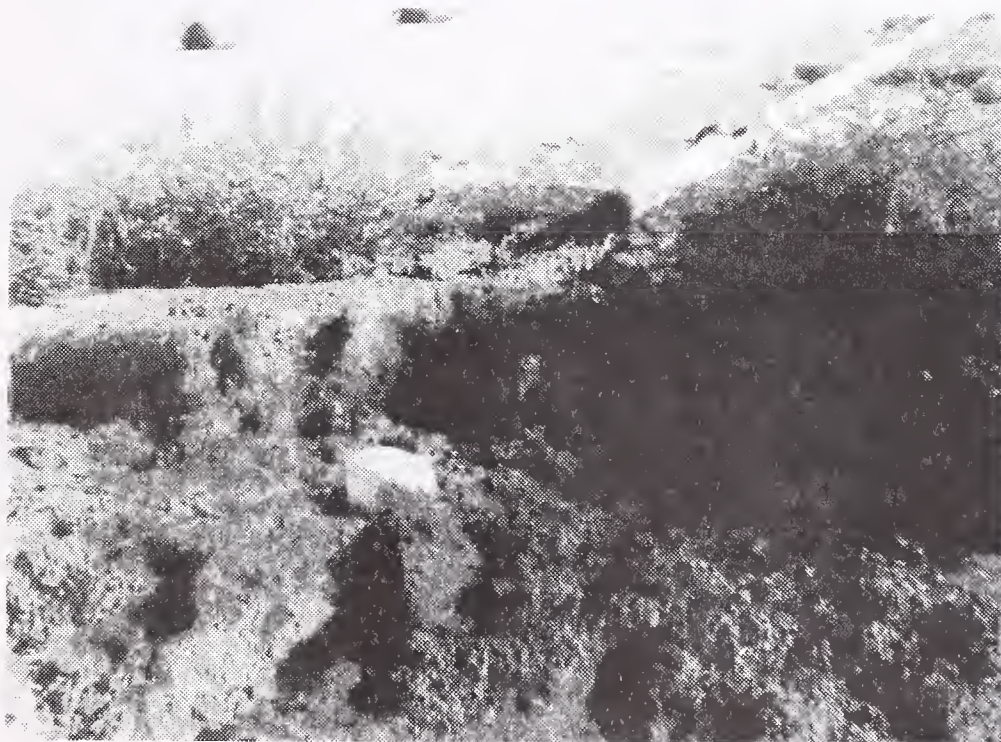
The upstream slope evidences no cracking, settlement, or substantial deviation from the planned slope. Pond water level prevented inspection of the berm at elevation 3260 feet. The soil-cement slope protection, with a plan thickness of 1.5 feet normal to the slope, has undergone moderate wave and runoff erosion, accounting for a loss in protective thickness estimated at less than 10 percent (Photos 2 and 3). Discharge waters from a pump station on the dam crest, near mid-dam are allowed to run over an isolated area on the lower portion of the slope. Considerable local erosion has resulted (Photo 4).

PHOTO 4  
Erosion Caused by Pipe Discharge

3. Repair erosion damage due to pump discharge running over upstream slope and modify procedures to avoid reoccurrences.
4. Repair surficial sloughs on the downstream slope.

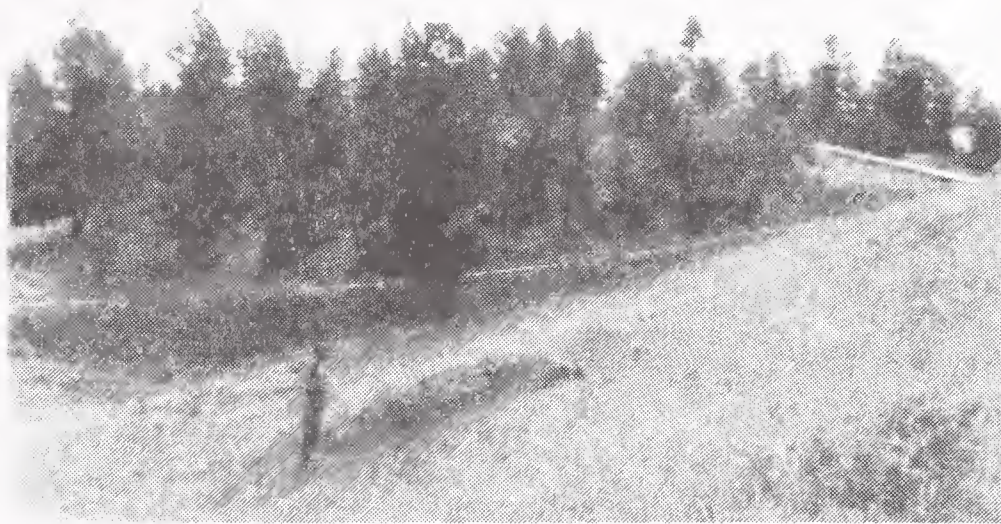
The downstream slope is generally well-covered by grasses, and shows no substantial deviation from the planned slope. The repair of some surficial sloughing was apparent near the right abutment and several minor, surficial sloughs were observed elsewhere along the slope (Photo 5). Only occasional animal burrows were noted. Minor runoff erosion rills at the abutment contacts were observed. No seepage was seen on the slope or in the abutment areas. Some runoff erosion exists on the bench above the toe drain near the middle of the dam. Runoff erosion has deepened and widened the drainage ditch downstream of the toe drain.

PHOTO 5  
Downstream Slope & Right Abutment  
Note: Minor Slough In Front of Man

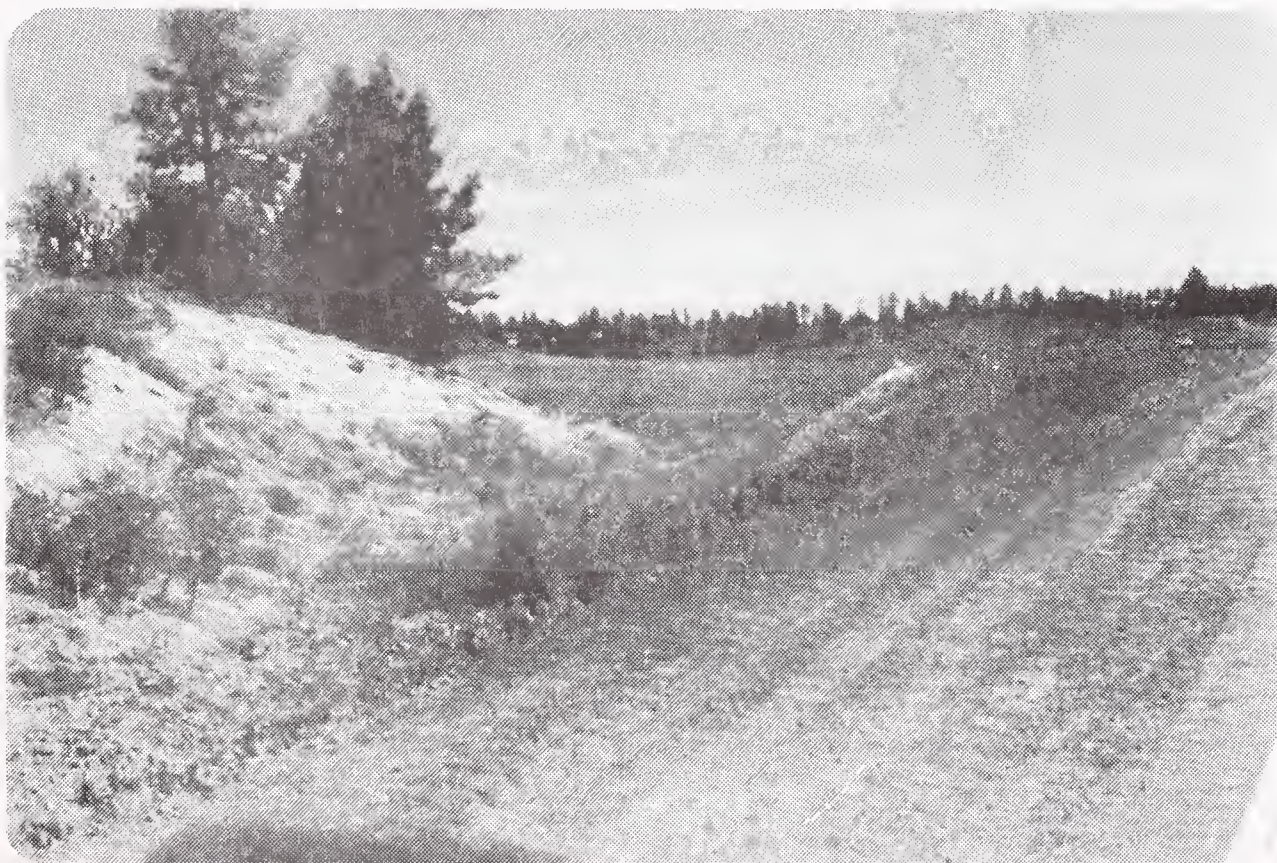
The emergency spillway for the Evaporation Pond Dam is excavated through broken sandstone material in the left abutment. (Plate 4). The spillway is unlined and has no grass cover on the bottom or sides. (Photo 6) The control section consists of an earth weir located near the axis of the dam embankment, with a crest elevation of 3304.0 feet NGVD. (Plate 7) This elevation is based on levels surveyed at the time of the site visit using known elevation 3308.9 feet NGVD for the top of a concrete base on the pump station located near the center of the dam. The crest of the emergency spillway is 4 feet below the dam crest elevation 3308.0 feet NGVD. The approach channel has an adverse slope of .02 and the exit channel has a slope of approximately 0.05. At the control section, the crest width is about 15 feet with 1V on 2.5H side slopes. Prolonged spillway flows would erode the exit channel. However, this should not endanger the dam embankment which is more than 50 feet to the right or east. It is our estimation that flows during the passage of the PMF would erode the channel but not cause irreparable damage.

Visual inspection of the emergency spillway shows it to be in good condition. Road maintenance could tend to obstruct the approach channel. Some minor erosion has occurred on the cut slopes of the downstream channel. (Plate 6)

PHOTO 6  
Emergency Spillway Entrance  
Note How Road Maintenance Partially Obstructs

Implement and periodically test a warning plan to warn downstream residents in the event of impending dam distress. Take precautions to insure the emergency spillway is not obstructed by future road maintenance. Monitoring of observation wells should be continued with evaluation by a geotechnical engineer as the pool level is increased toward design maximums. Repair erosion damage due to pump discharge running over upstream slope and modify procedures to avoid reoccurrences. Repair surficial sloughs on the downstream slope. Provide runoff erosion protection for the ditch drain along the downstream toe. Visit the site during and after passage of significant runoff events. Study diversion system discharge characteristics and implement modifications if required. Conduct periodic inspections of the facility at least at 5 year intervals by engineers with experience in dam design and construction.

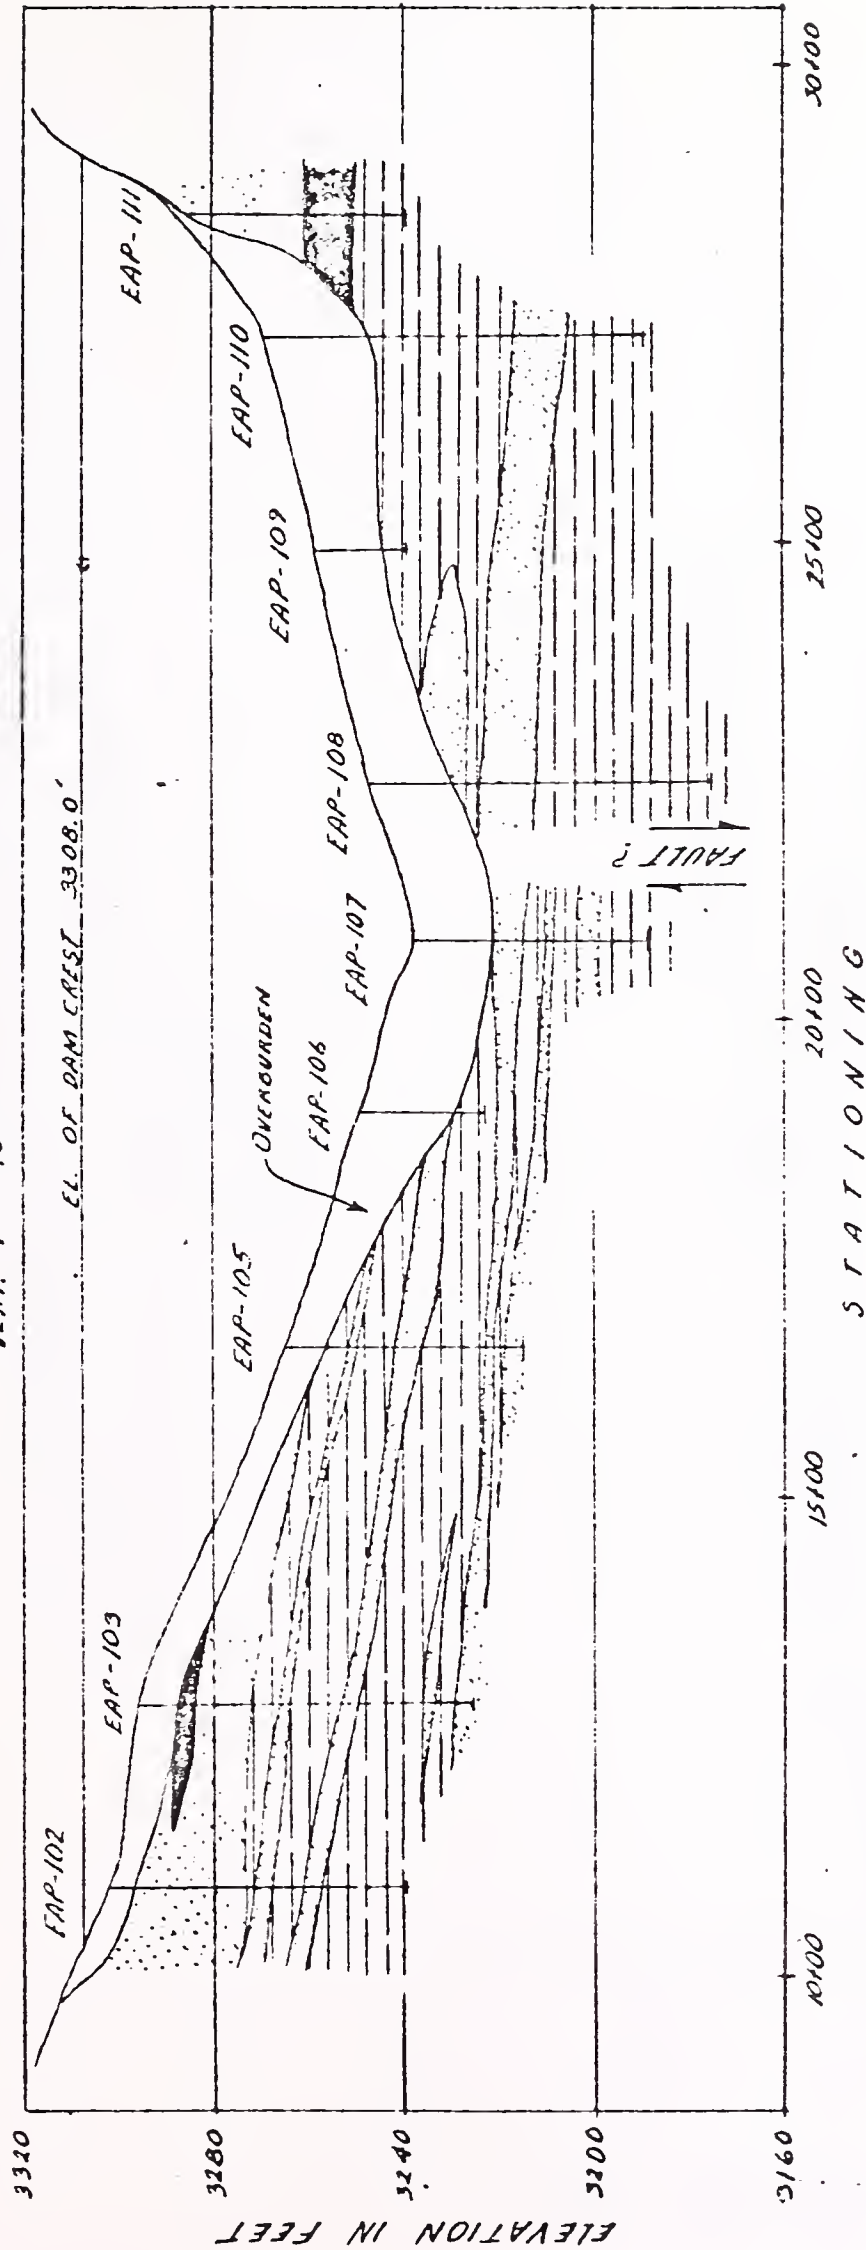
# PLATE -6- EVAPORATION POND DAM - PROFILE

The geologic profile at the dam site shown on Plate 6 was constructed using subsurface data presented in the Bechtel Design Report, and confirmed to the extent possible by our recent field observations. The field exploration from which the geologic data were gathered was conducted by NTL in 1975. Subsequent laboratory testing to determine index and engineering properties of representative foundation materials was also performed by NTL. Test results are presented in the aforementioned Design Report. (Ref. 8)

The preconstruction geologic profile along the dam axis indicates a soil overburden varying in thickness from several feet on the gently sloping valley walls forming the left abutment, to as much as 20 feet along the valley floor and near the right abutment. The overburden soils were generally loose to medium dense clayey silts and sands, randomly interspersed with firm to stiff silty and sandy clays.

The predominant sandstone bedrock underlying the site is interbedded with shale and siltstone, and is weathered, friable, and poorly to moderately cemented near the surface. Coal layers near both abutments and discontinuous, thin coal seams were encountered in the valley floor bedrock. The coal layers found near the abutment had apparently been eroded from the lower elevations of the valley floor.
